Shire of Mundaring

Asbestos Management Plan

Boya Oval Change Rooms & Toilet –
119 Scott Street,
Boya WA 6056

5 February 2024

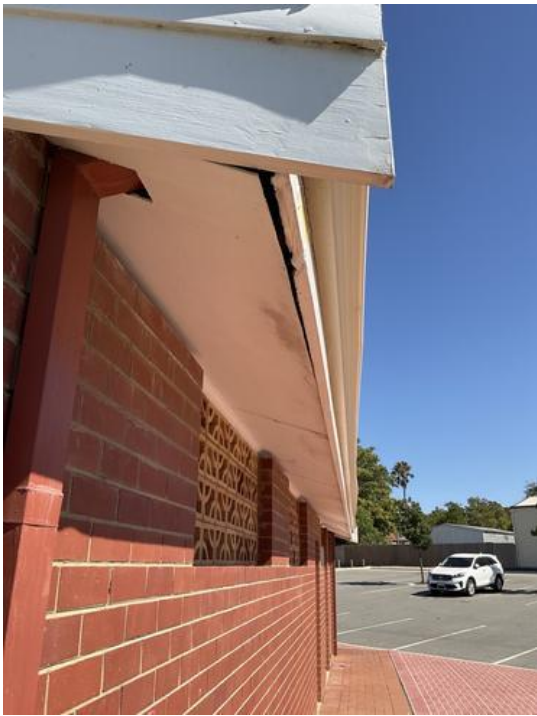
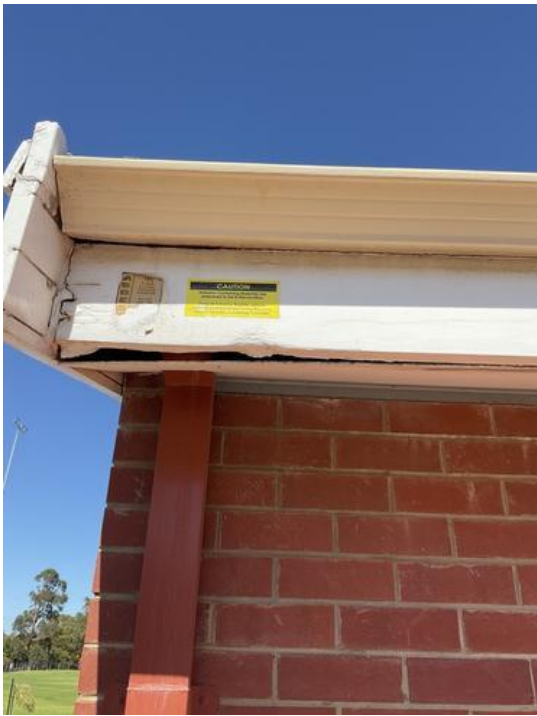
Photo 9		Photo 10
Asbestos Containing Material	ACM suspected	
Material type	Hardiflex sheeting	
Condition	Good	
Details on Condition:	Intact	
Quantity sqm (apx)	5	
Friable or Non-Friable	Non-Friable	
Is this an inaccessible area?	Only accessed by maintenance staff / contractors	
Actions for consideration:		
Consider safe removal & replace with non ACM	Consider sealing the ACM appropriately	Monitor and Review the ACM's condition
	Consider safely sampling the ACM for verification	Signify ACM present
Other details:		
Removal by a licenced asbestos contractor during refurbishment or demolition		
Monitor and review for wear and damages
