Asbestos Management Plan

Chidlow Family Playgroup & Community
Kindergarten/Health Clinic –
Lot 266 Northcote Street,
Chidlow WA 6556

12 February 2024

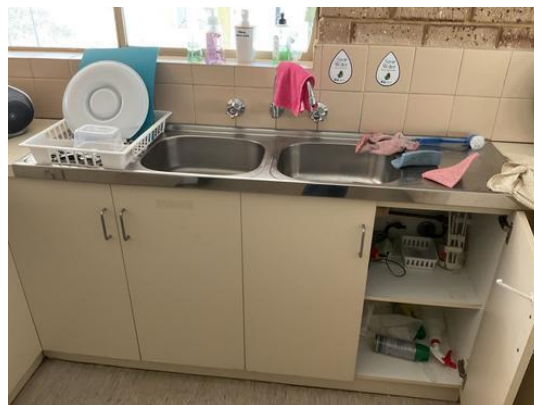
Photo 2

Kitchen Sink Blackjack Spray Resin Backing

Blackjack spray resin backing

Good

Intact

Non-Friable

Accessible: unlikely to be damaged

Monitor and review for wear and damages
Removal by a licenced asbestos contractor during refurbishment or demolition
