Shire of Mundaring Asbestos Management Plan

Glen Oval Change Rooms – Lot 94 Marnie Road, Glen Forrest WA 6071

5 February 2024

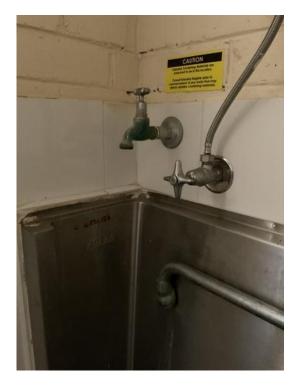
Photo 1 Conducted on **Prepared by**

Location

Lot 94 Marnie Road Glen Forrest WA 6071 Australia (-31.908048833086088, 116.1015026896429)

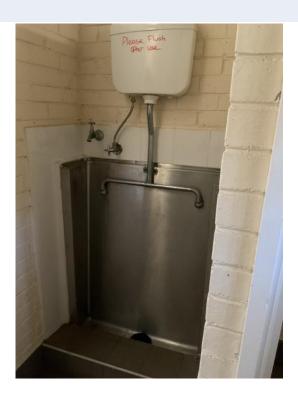
Home Change Room Urinals Blackjack Spray Resin Backing

Photo 2	Photo 3	Photo 4	
Asbestos C	Containing Mate	erial	ACM suspected
Material typ	ре		Other
Details:			Blackjack black spray resin backing
Condition			Good
Details on	Condition:		Assumed intact
Quantity so	qm (apx)		2
Friable or N	Non-Friable		Non-Friable
Is this an ir	naccessible are	a?	Only accessed by maintenance staff / contractors
Actions for	consideration	:	
	safe removal & with non ACM	Monitor and Review the ACM's condition	Consider safely sampling the ACM for verification
			Signify ACM present

Monitor and review for wear and damages Removal by a licenced asbestos contractor during refurbishment or demolition

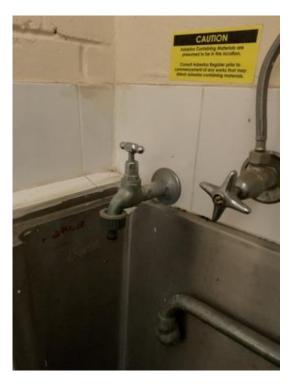
Away Change Room Urinal Blackjack Spray Resin Backing

Photo 5	Photo 6	Photo 7						
Asbestos Co	ntaining Mate	ACM suspected						
Material type	9	Other						
Details:			Blackjack spray resin backing					
Condition			Good					
Details on Co	ondition:		Assumed intact					
Quantity sqn	n (apx)		2					
Friable or No	on-Friable		Non-Friable					
Is this an ina	ccessible are	Only accessed by maintenance staff / contractors						
Actions for consideration:								
	ife removal & with non ACM	Monitor and Review the ACM's condition	Consider safely sampling the ACM for verification					
			Signify ACM present

Monitor and review for wear and damages Removal by a licenced asbestos contractor during refurbishment or demolition
