Shire of Mundaring

Asbestos Management Plan

Marloo Hall Theatre –
20 Marloo Road,
Greenmount WA 6056

9 February 2024

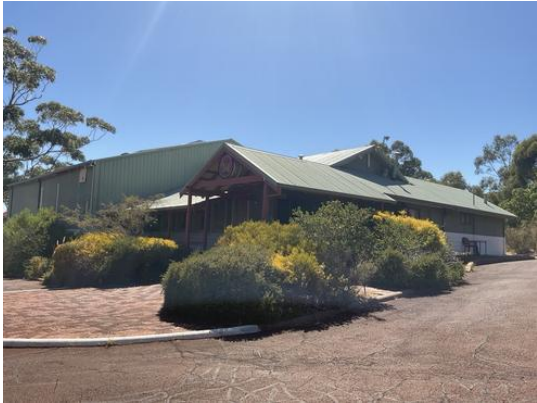
Photo 1

Marloo Hall Theatre

20 Marloo Rd
Greenmount WA 6056
Australia
(-31.897544028979564,
116.0531089888052)

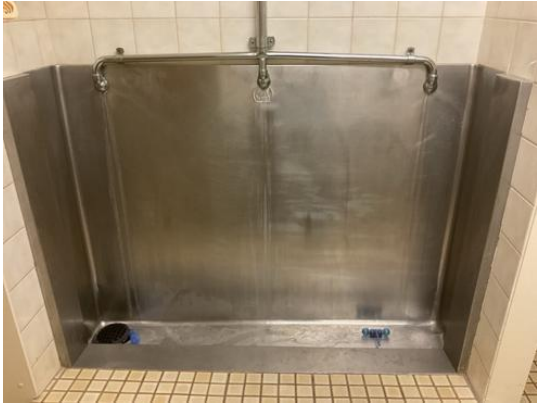
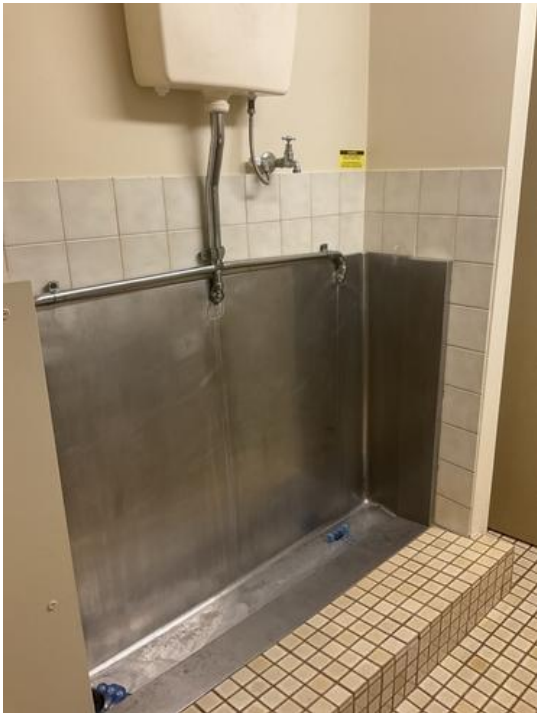
Photo 2

Describe location of the ACM/Presumed ACM
Male Toilet Urinal Blackjack Spray Resin Backing

ACM suspected
Other
Blackjack spray resin backing
Good
Assumed intact
3
Non-Friable
Only accessed by maintenance staff / contractors

Monitor and review for wear and damages
Removal by a licenced asbestos contractor during refurbishment or demolition

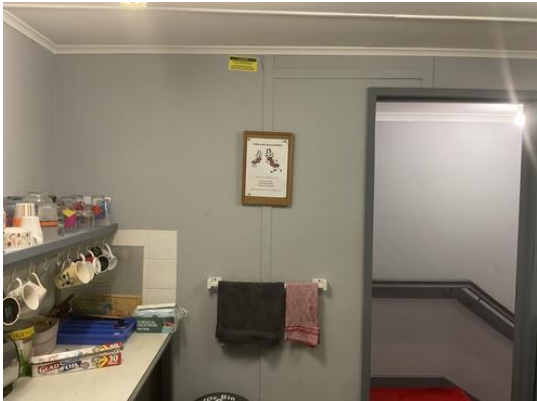
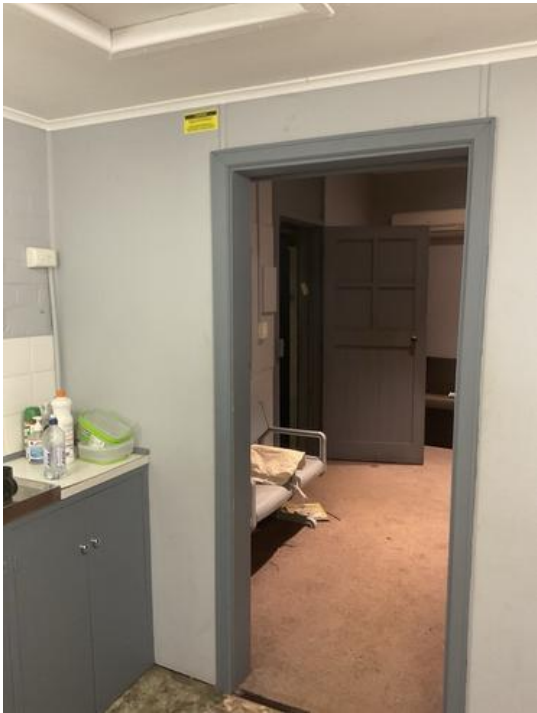
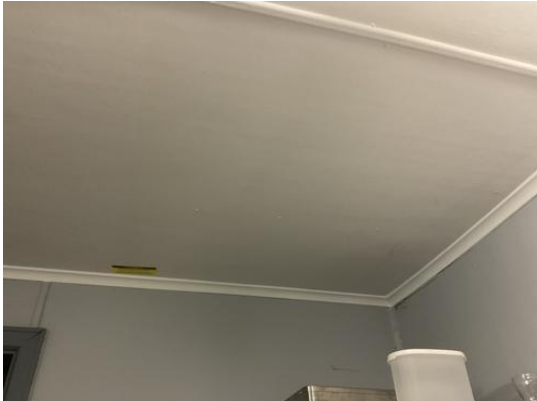
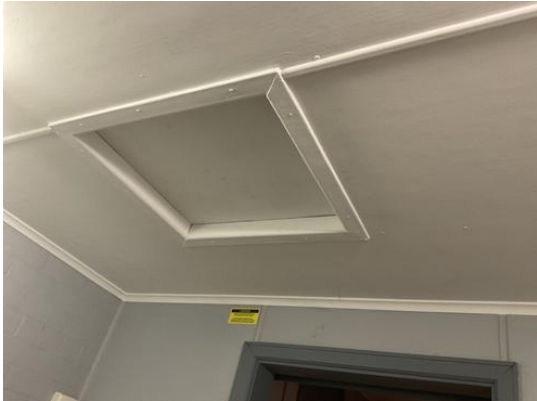
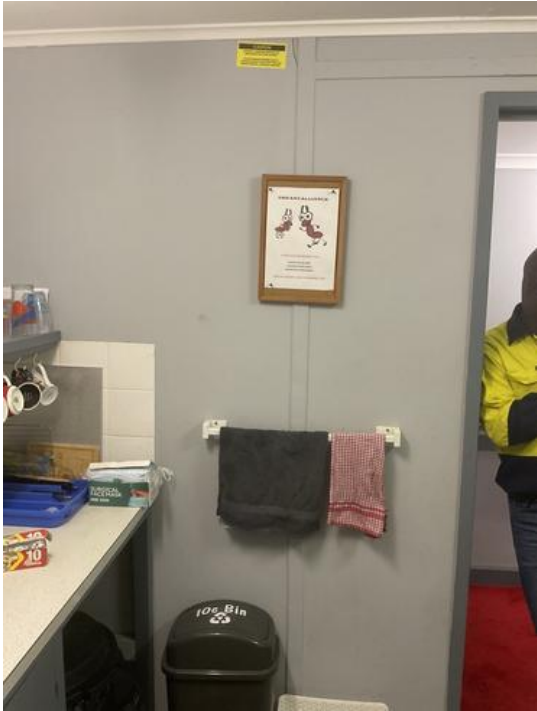
Photo 4

Green Room Kitchen Ceiling & Walls

ACM suspected
Hardiflex sheeting

Good

25

Consider safe removal & replace with non ACM	Consider sealing the ACM appropriately	Monitor and Review the ACM's condition
	Consider safely sampling the ACM for verification	Signify ACM present

Monitor and review for wear and damages
