Shire of Mundaring

Asbestos Management Plan

Mundaring Weir Hall – Arts & Crafts –
Lot 7783 Hall Road,
Mundaring WA 6073

12 February 2024

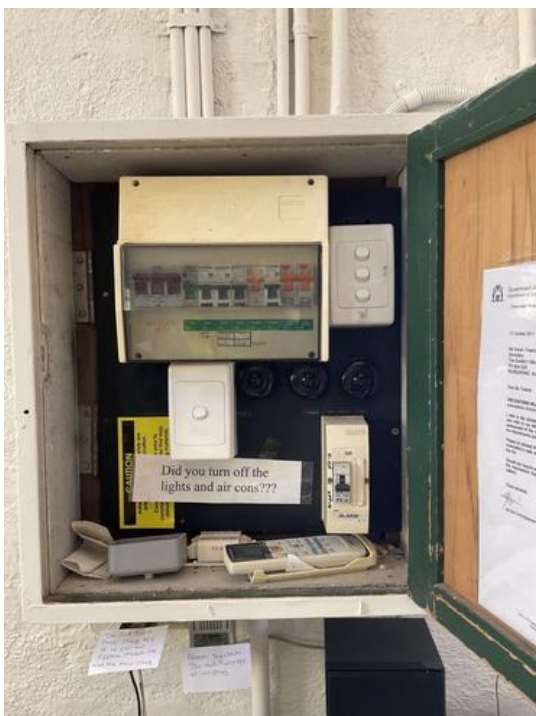
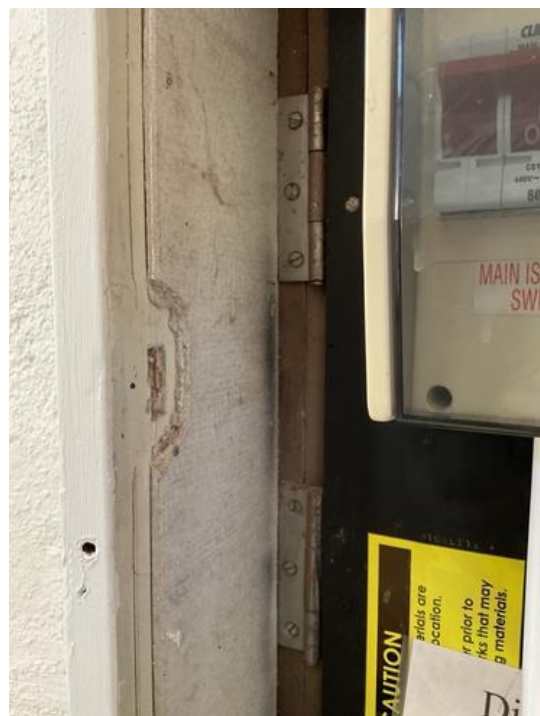
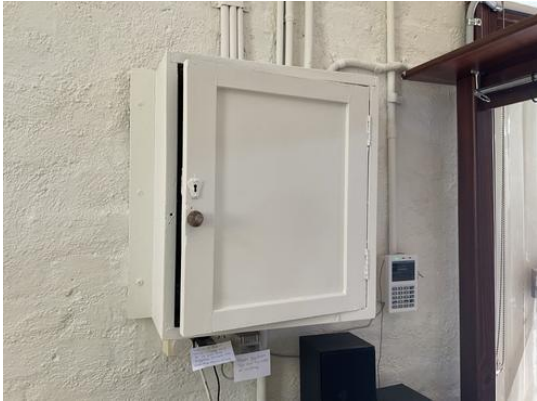
Interior Switchboard and Lining

Zemolite

Lining unsealed and damaged edges

Non-Friable

Accessible: potential to be damaged

Seal lining or remove and replace with non-ACM product

Monitor and review for wear and damages

Removal by a licenced asbestos contractor during refurbishment or demolition
